Mill Creek Watershed WESTMORELAND COUNTY PENNSYLVANIA

Conservation Plan

Prepared By The Forbes Trail Chapter Of Trout Unlimited Funded By A Grant From The Coldwater Heritage Partnership

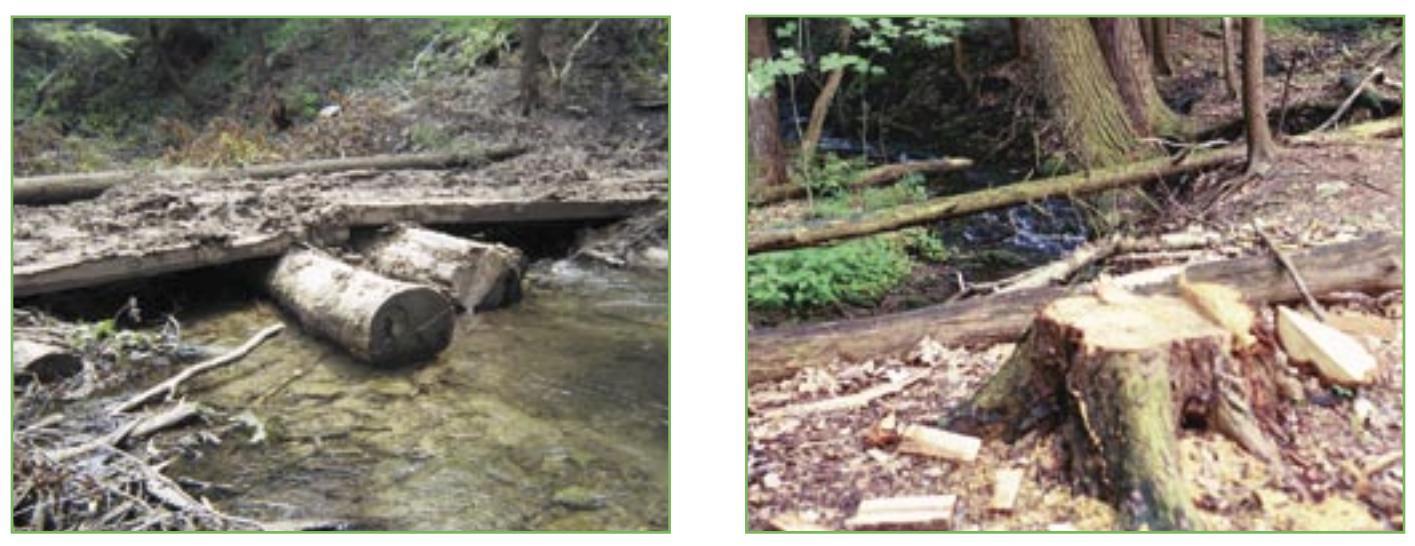
Logging to the stream's edge exposes the water to the heat of the sun, allows siltation and destabilizes the stream banks.

The Middle Branch is designated as EV. During the assessment of this tributary, a less than desirable timbering practice was found on the left fork. There is a long stretch of the stream (approximately a quarter mile) where the canopy protecting the left fork was clear-cut on both sides of the stream. The stream was congested with treetops and debris. Little protection was in place to prevent silt from entering the stream from logging roads.

FTTU, that some form of stream protection should be in place for the timbering industry, particularly along streams designated as HQ or EV. Without protection, the designation provides little meaning.

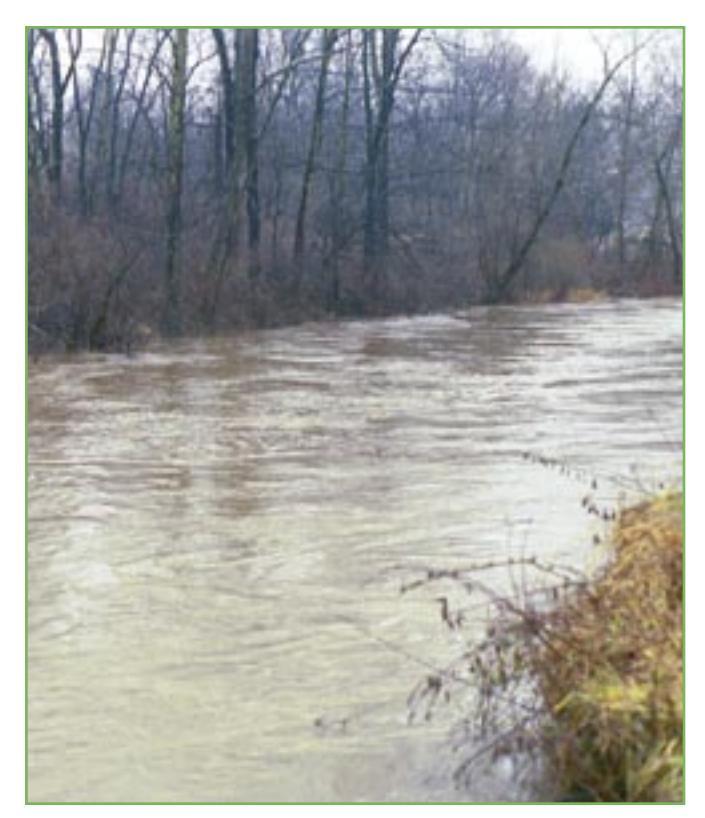
The lower section of Mill Creek carries a heavy silt load after a rain storm.

Waterford. Below Waterford, it would be off-color due to Macs Run. However, after the confluence with Hannas Run, Mill Creek often has a brown, muddy color. Hannas Run, probably the most impacted tributary, enters Mill Creek below the town of Oakgrove and deposits a large silt load during these conditions.

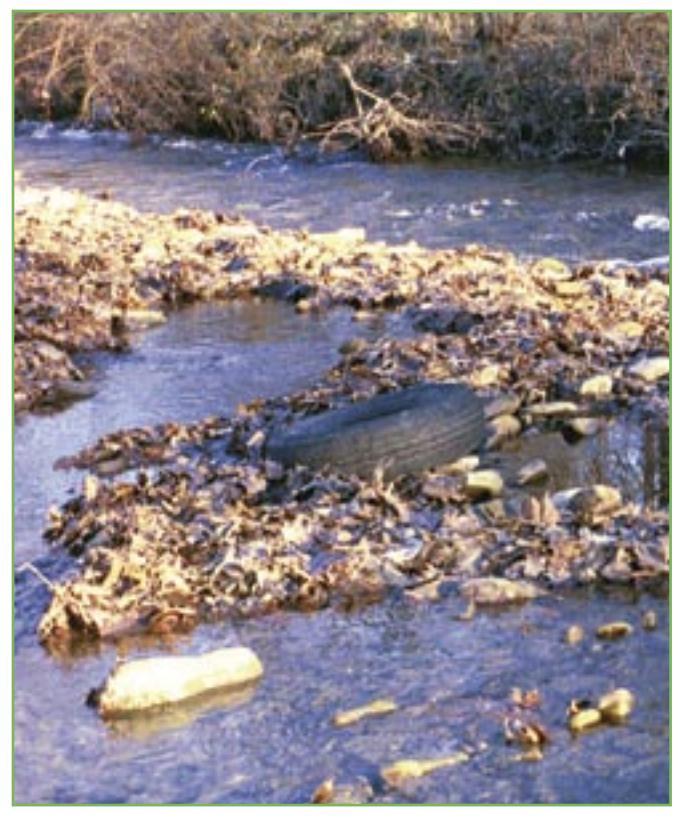
Some careless individuals see streams as just a convenient place to discard trash and unwanted items.

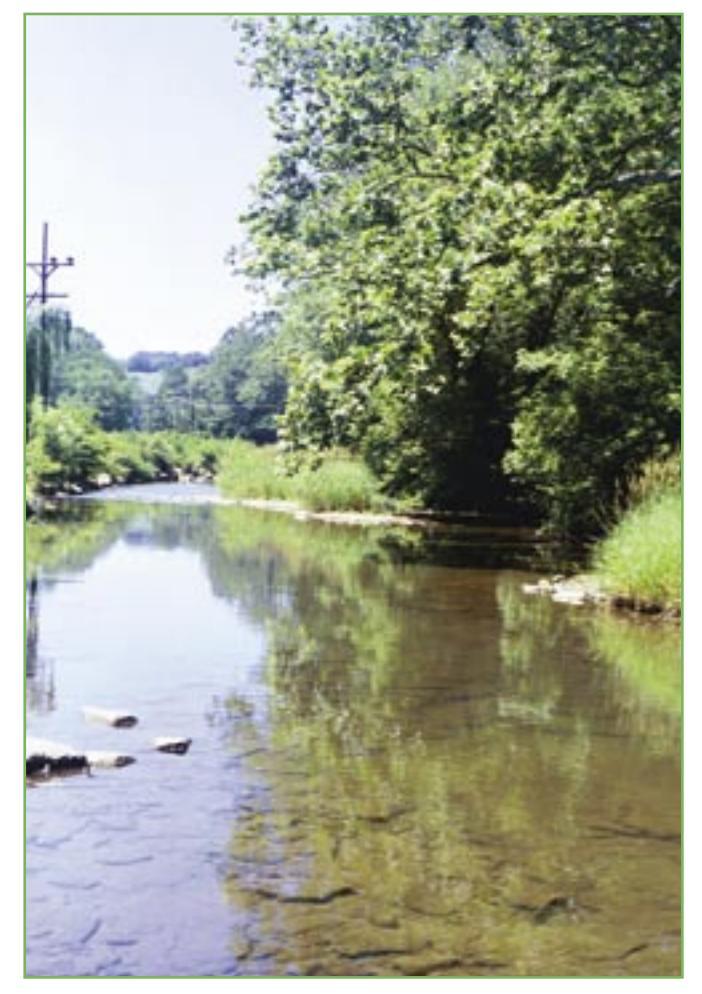
A section of bank is slowly sliding into the stream forming an island. The flow is moving away from the center of the stream.

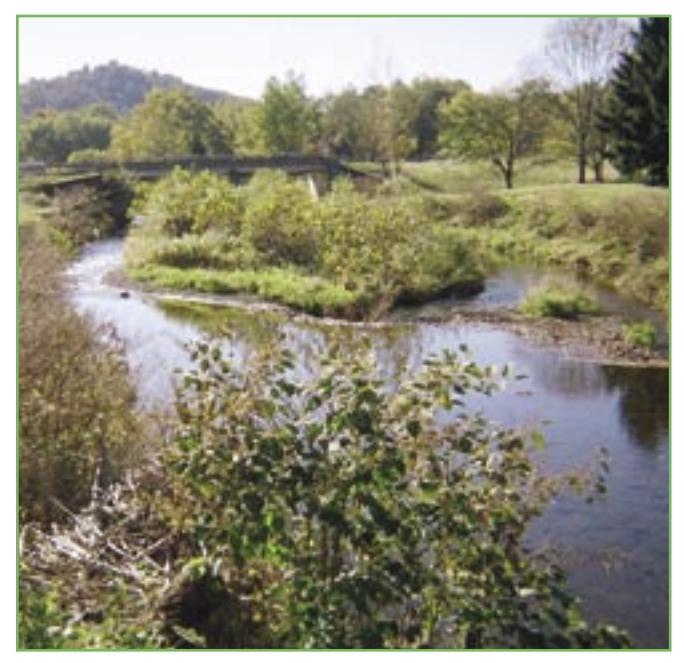
An island formed by siltation.

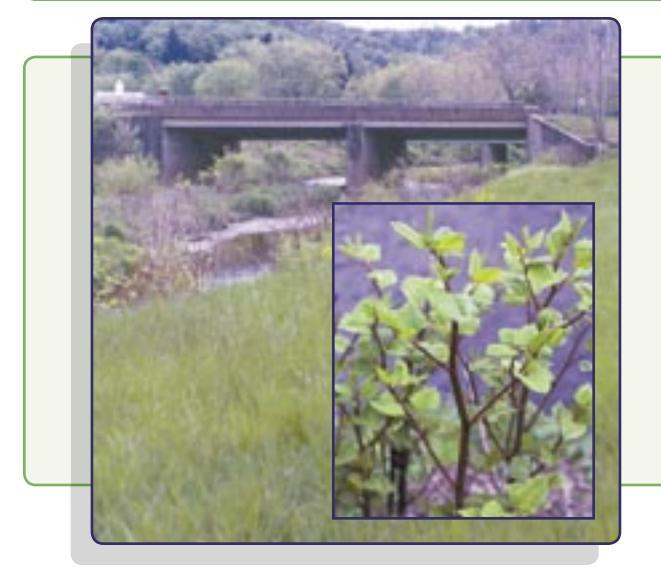
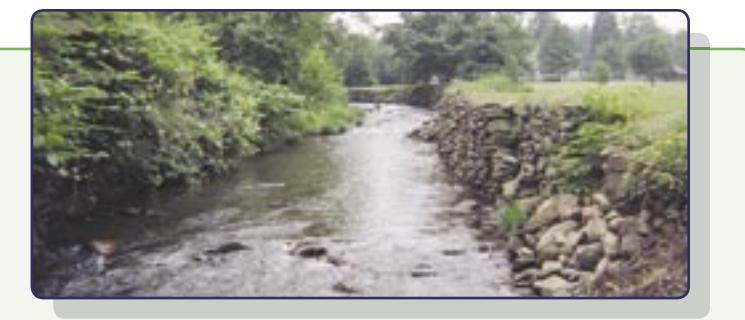
Areas where riparian vegetation has been removed are susceptible to erosion, allow invasive species such as Japanese Knotweed to move in and expose the stream to the warming effects of direct sunlight.

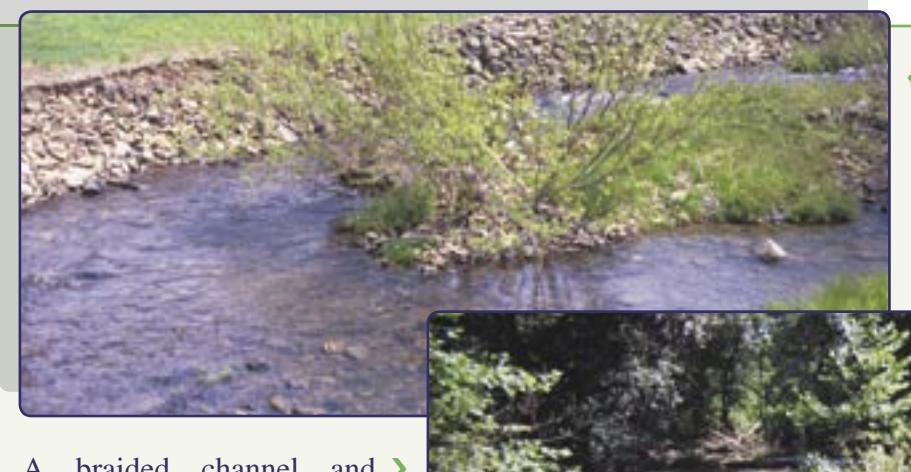
A lack of riparian cover has exposed the stream to the warming effects of sunlight. The stream has dropped sediment here forming an island.

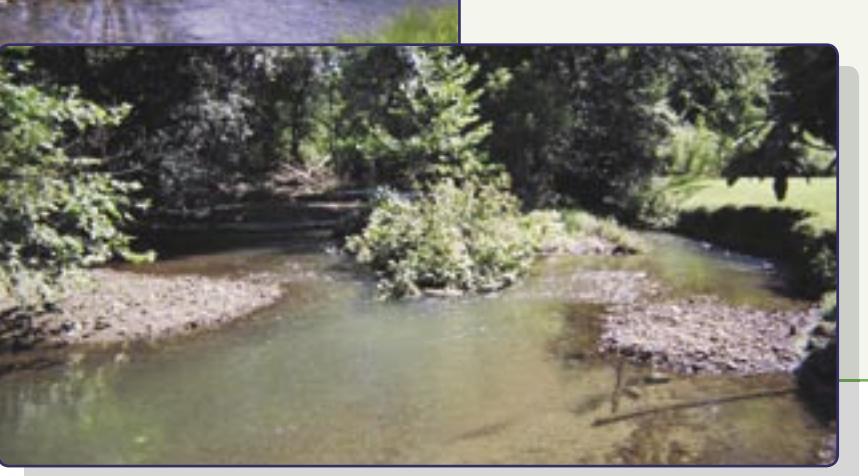
A braided channel and > excessive siltation. The absence of riparian vegetation has allowed the bank to erode.

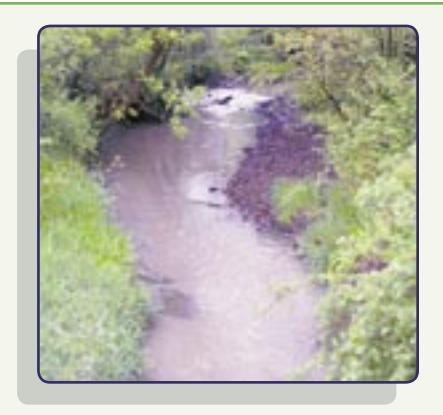
Mill Creek's tributaries muddy quickly in a rainstorm and bring in silt, smothering the cobblestones and woody debris in the stream bed that serves as habitat for macroinvertebrates.

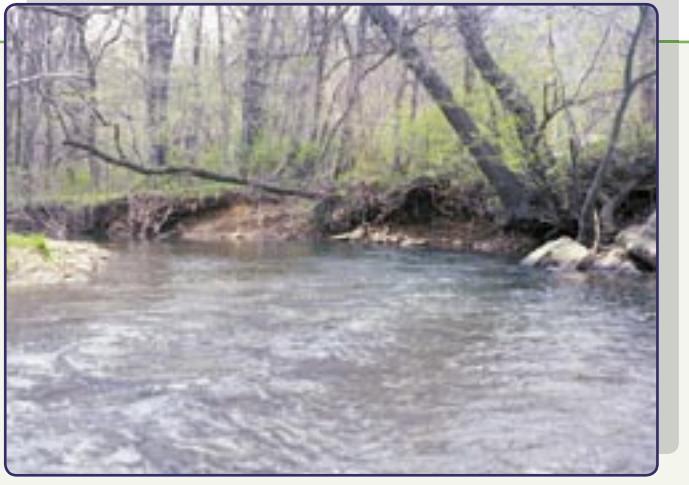
The most impacted area in this section is the highly eroded bank at the end of Mallard Road. Some large rocks have been placed above this section to protect the road. The erosion, which begins just after this area, would be a high priority for FTTU to repair. This could be accomplished by further extending the stabilization efforts to protect the roadway and by constructing fish habitat devices. Partnering with landowners and other agencies, such as Ligonier Township and the PAFBC, would benefit this area.

Bank erosion in the Mallard Lane area.

Mill Creek by Mallard Lane	Homeowners have removed vegetation along stream banks with lawnmowers.	 Riparian planting Educate public and landowners on importance of streamside buffers 	• DEP • LWV WREN • PACD • USDA • WPWP	High
Mill Creek from West Main Street Bridge to the mouth	Riparian vegetation is severely limited due to roads. Only grasses line banks. Very few trees are located on either side of the bank.	 Limit dredging Install instream structures to keep flow in center of stream channel so silt will be deposited on the banks 	• EPA • DEP • NFWF • USDA • WPWP	Medium
Numerous un- named tributaries to Mill Creek	Most are impacted by landowners mowing to banks and/or agriculture	 Riparian planting Educate public and landowners on importance of streamside buffers 	• DEP • LWV WREN • PACD • USDA • WPWP	High

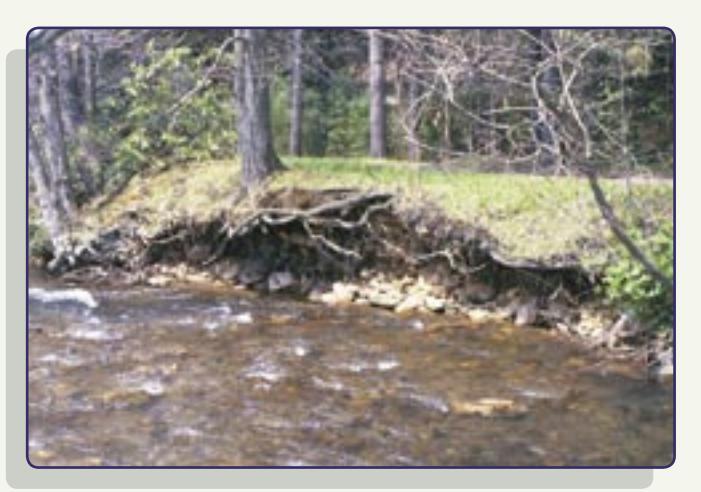
▲ Bank erosion threatens a private road.

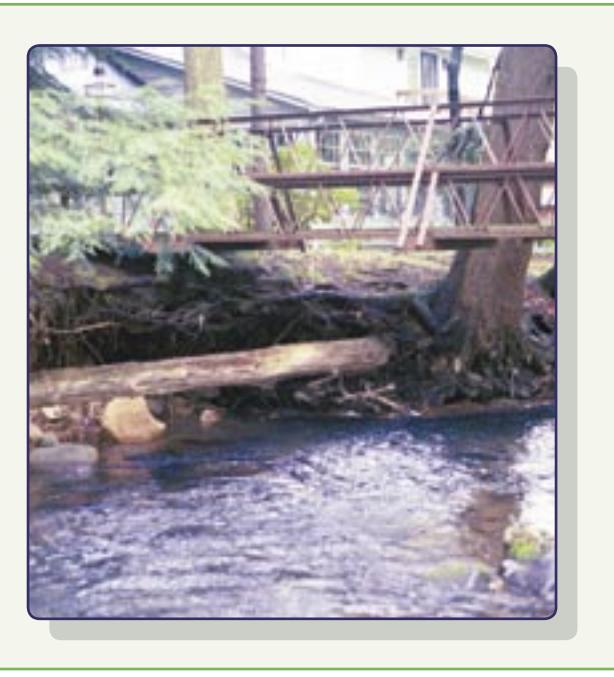
A severely eroded bank and a hemlock tree > in danger of falling in the Mill Road area.

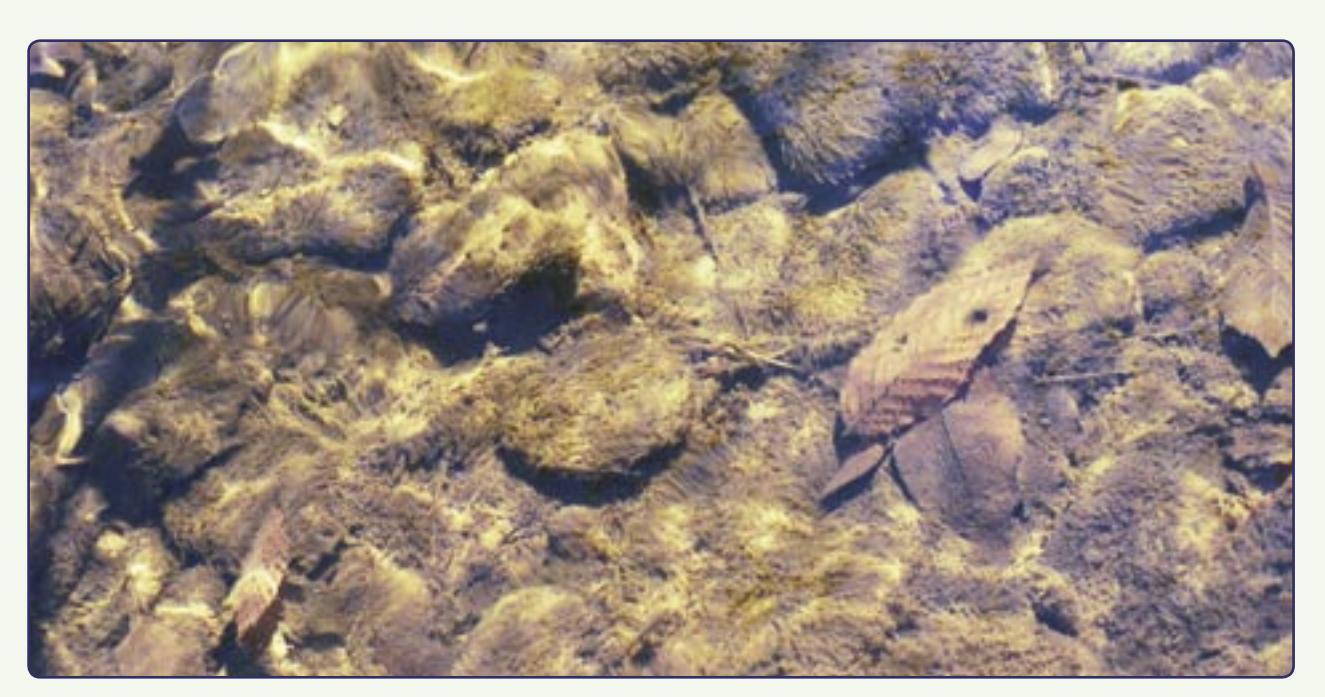
Excessive algae growth from nutrient enrichment.
