**LOWER LITTLE SANDY CREEK  
WATERSHED ASSESSMENT  
REPORT**

**REDBANK TOWNSHIP  
ARMSTRONG COUNTY, PA**

**PREPARED BY:**  
**DAVID E. BEALE, WATERSHED SPECIALIST**  
**AND**  
**ROBERT GOROG**

**February 1, 2001**

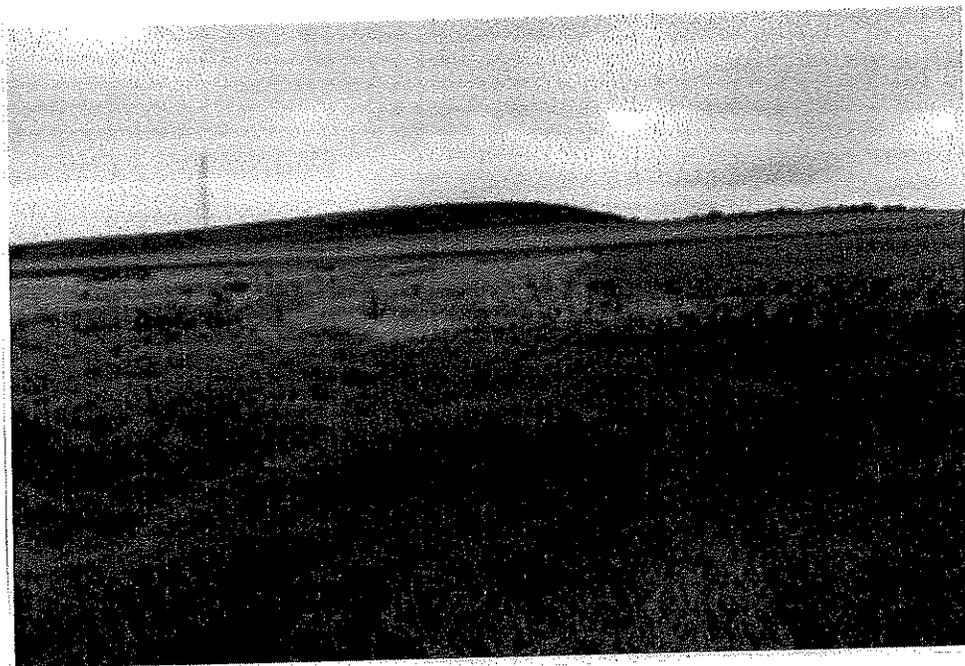
One area of farmland along a tributary to Nolf Run located south of Route 536 and west of SR 1019 extends to the edge of the stream. At this site, cropland and hayland extend to the stream banks. It is likely that increased siltation and nutrient enrichment has occurred along this tributary as a result of this condition. The soils within this zone are Melvin and Ernest Silt Loam on slopes of 0-8%. These soils are Hydric units in Armstrong County.

South of Route 536, the riparian zone is in agriculture. The stream in this area would greatly benefit from establishment of riparian corridors.

View of agricultural land in the  
valley of a tributary of Nolf Run  
looking south from Route 536.

4. Law enforcement agencies should be encouraged to actively prosecute illicit ATV use. ATV users should be educated as to the damage caused by irresponsible activities.
5. Areas of agricultural impairment along the tributary to Nolf Run should have riparian zones restored.
6. An area of three to five Acres immediately south of Route 536 along the Nolf Run Tributary is a candidate for establishment of a wetland. At present this area is in open hayland, which was not cut in 1999.
7. At present, the study area, although under private ownership, is largely open to the public. The owners should be encouraged not to post the area against responsible outdoor recreation.
