Mill Creek Watershed

WESTMORELAND COUNTY PENNSYLVANIA

Conservation Plan

Prepared By The Forbes Trail Chapter Of Trout Unlimited

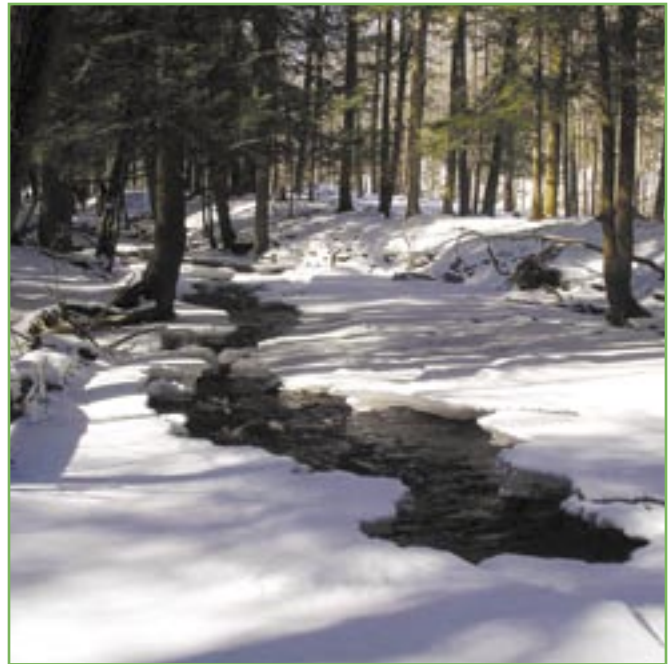
The cold waters of the North Branch in winter.

During our assessment the North Branch was rated as "Excellent".

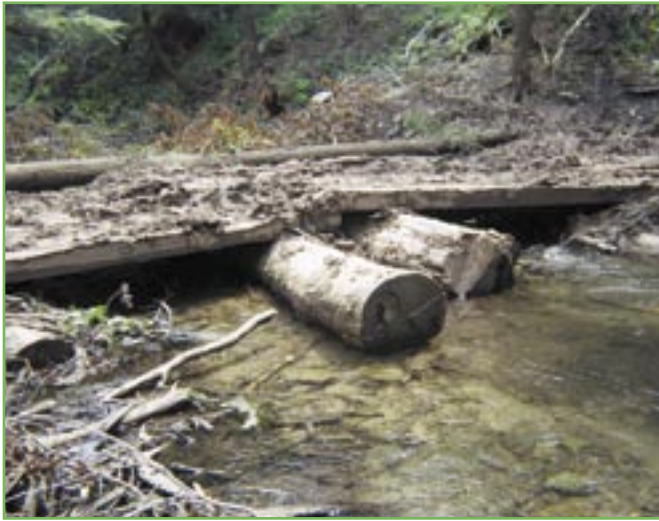
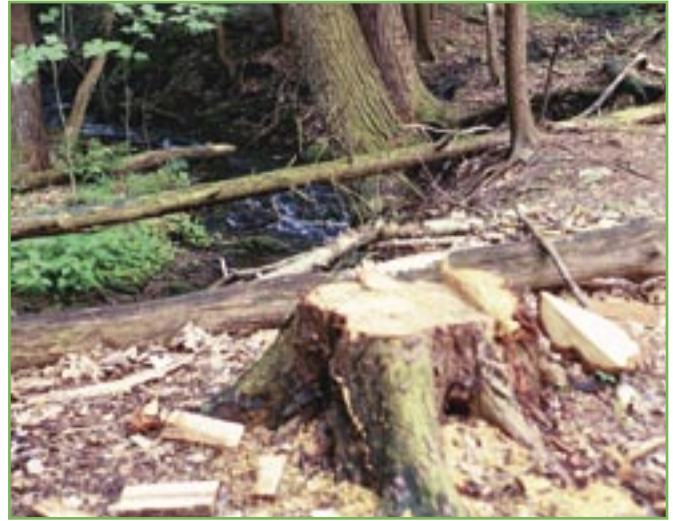
Logging to the stream's edge exposes the water to the heat of the sun, allows siltation and destabilizes the stream banks.

The Middle Branch is designated as EV. During the assessment of this tributary, a less than desirable timbering practice was found on the left fork. There is a long stretch of the stream (approximately a quarter mile) where the canopy protecting the left fork was clear-cut on both sides of the stream. The stream was congested with treetops and debris. Little protection was in place to prevent silt from entering the stream from logging roads.

FTTU, that some form of stream protection should be in place for the timbering industry, particularly along streams designated as HQ or EV. Without protection, the designation provides little meaning.

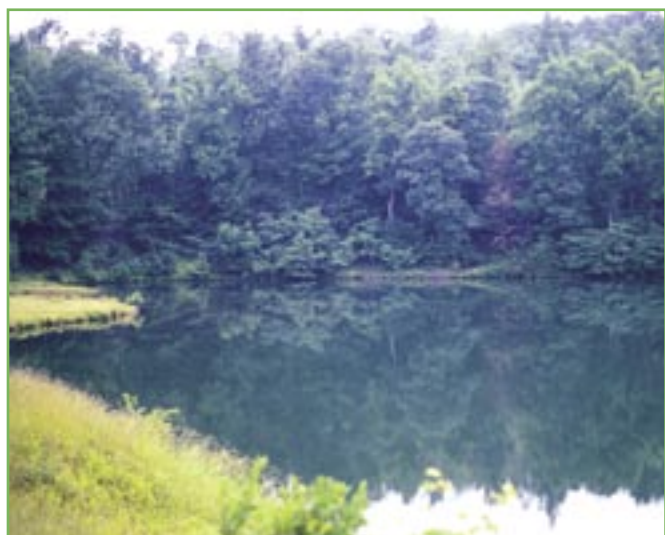
South Fork, downstream of the State Game Lands, does encounter some problems. The reservoir is a large open area, which slows the stream flow and exposes South Fork's waters to the heat of the sun. Some selective logging was noted in this area and includes some trees cut right on the stream banks. Homemade dams, while providing fish habitat, also collect silt and act as barriers to fish movement.

South Fork flows into the Ligonier Reservoir.

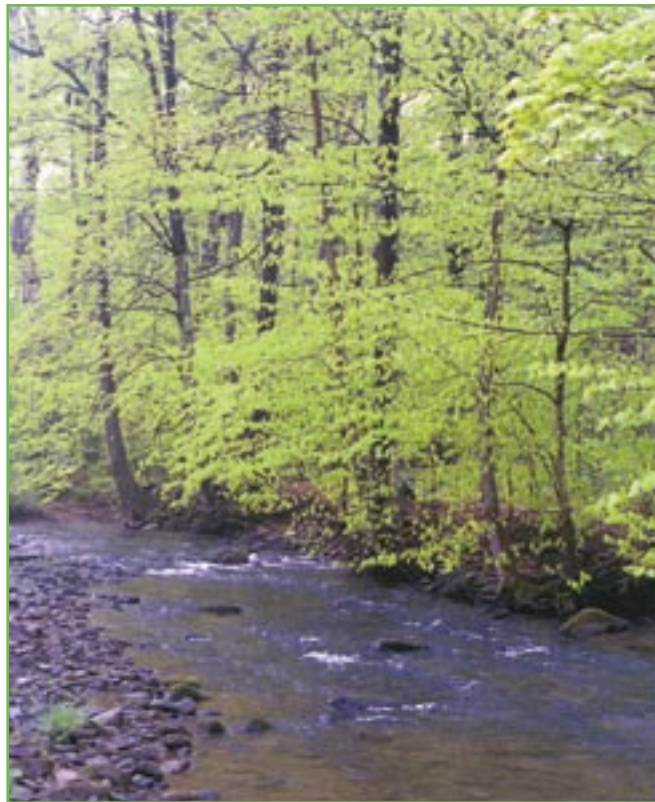
for anglers. This area was rated high in the following sections of our visual assessment: good canopy (large trees providing cover and shade), many fine pools (deep areas for fish to find cold water), riffles (moving water to provide oxygen), and pocket water (deep runs with large stones in the stream to provide cover for fish). Development has not yet occurred along this section. Through educating property owners about land conservation options, FTTU seeks to protect and enhance this important section of Mill Creek. This area also has tremendous potential for future habitat enhancement. Log veins and some minor bank stabilization, including deflectors, would help to narrow the stream where needed.

During the assessment, a wide, flat and shallow section was found. Areas such as this one provide little habitat and usually occur when a stream's flow begins to move away from the center of the stream bed. This section would be a good area for deflectors to help narrow the channel and create improved habitat. Deflectors help direct the flow toward the center of the stream. This allows the stream to deepen and narrow itself through time. A narrow, deeper stream helps to keep water colder and provides better habitat for trout and other aquatic species.

Mill Creek downstream of the McKelvey Bridge.

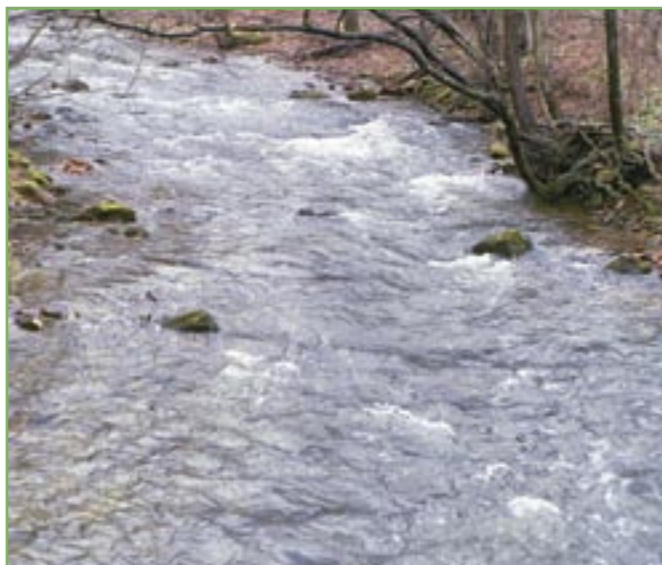
Mill Creek flows relatively clear during high water just above the Ann Roberts bridge

Waterford. Below Waterford, it would be off-color due to Macs Run. However, after the confluence with Hannas Run, Mill Creek often has a brown, muddy color. Hannas Run, probably the most impacted tributary, enters Mill Creek below the town of Oakgrove and deposits a large silt load during these conditions.

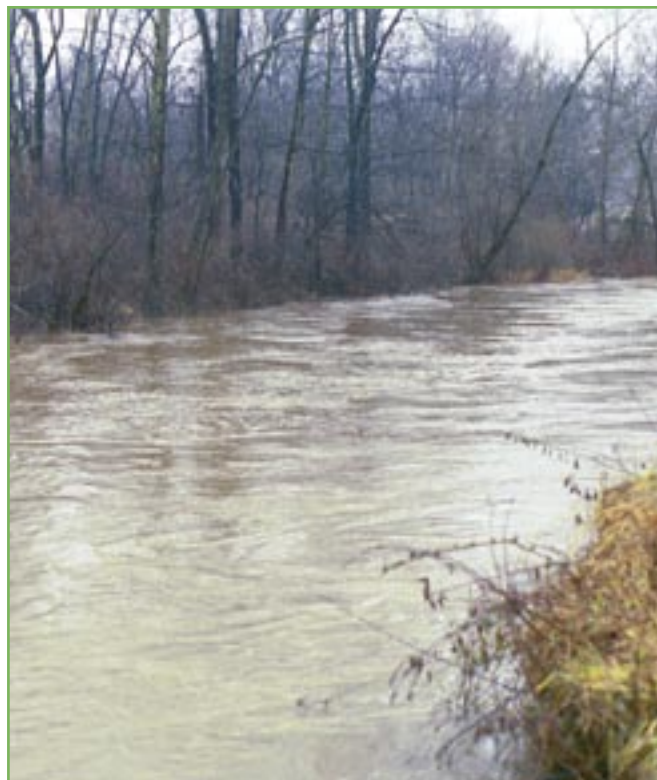
The lower section of Mill Creek carries a heavy silt load after a rain storm.

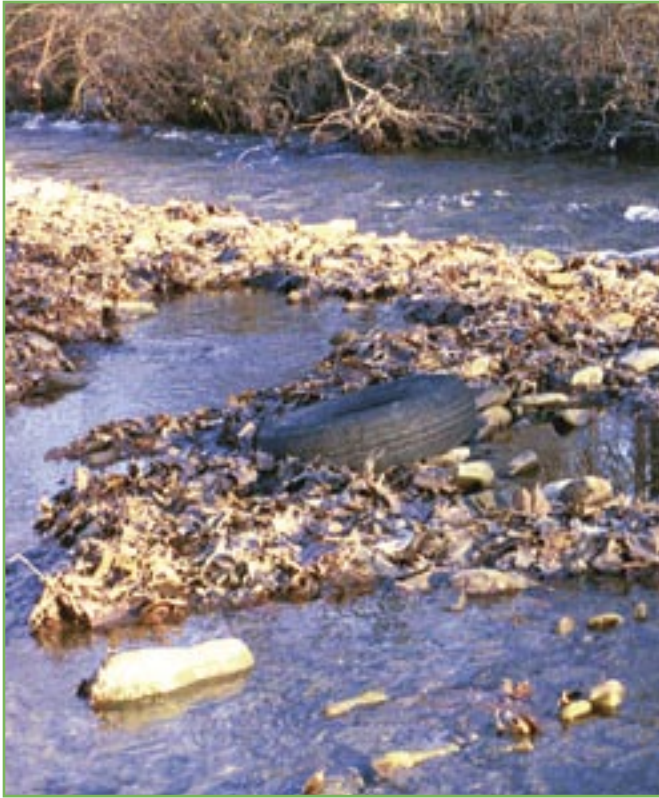
Some careless individuals see streams as just a convenient place to discard trash and unwanted items.

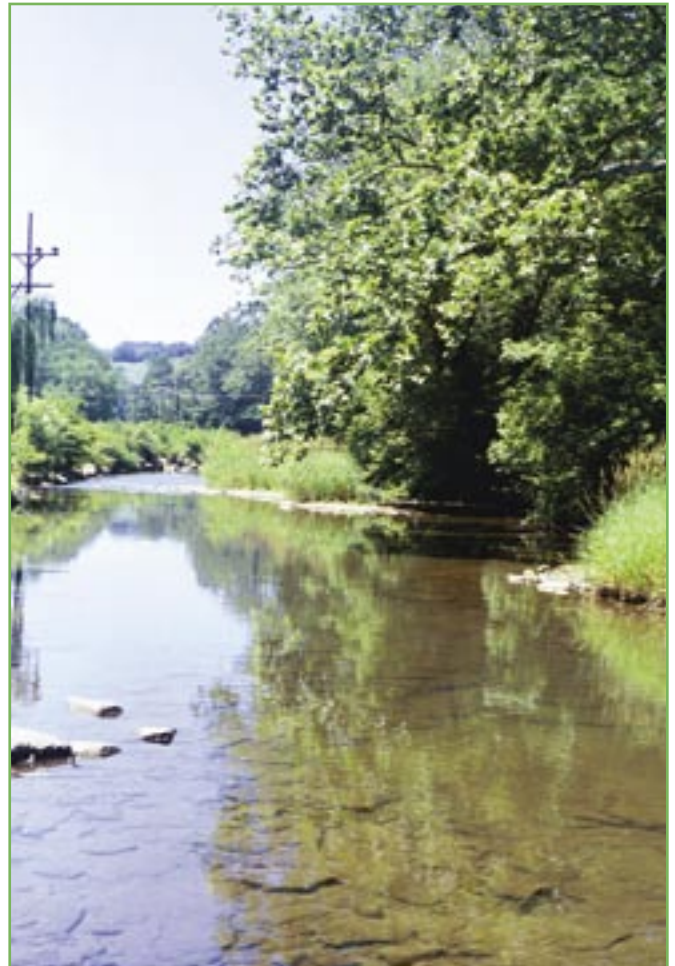
A section of bank is slowly sliding into the stream forming an island. The flow is moving away from the center of the stream.

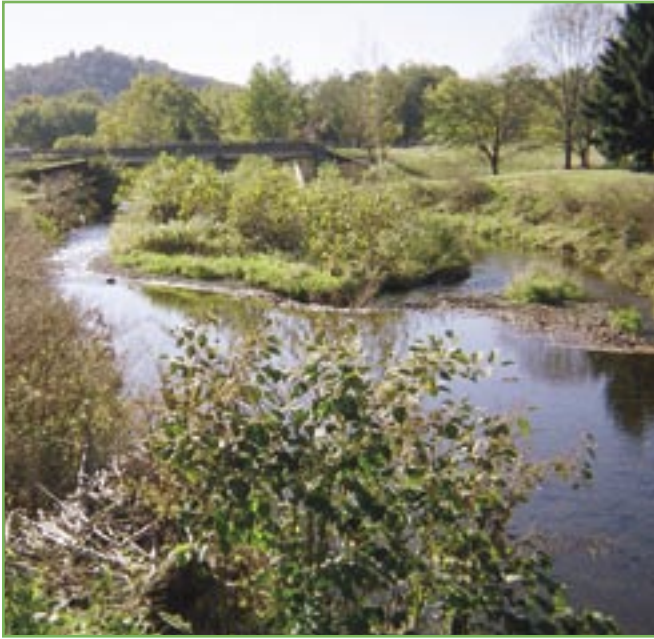
An island formed by siltation.

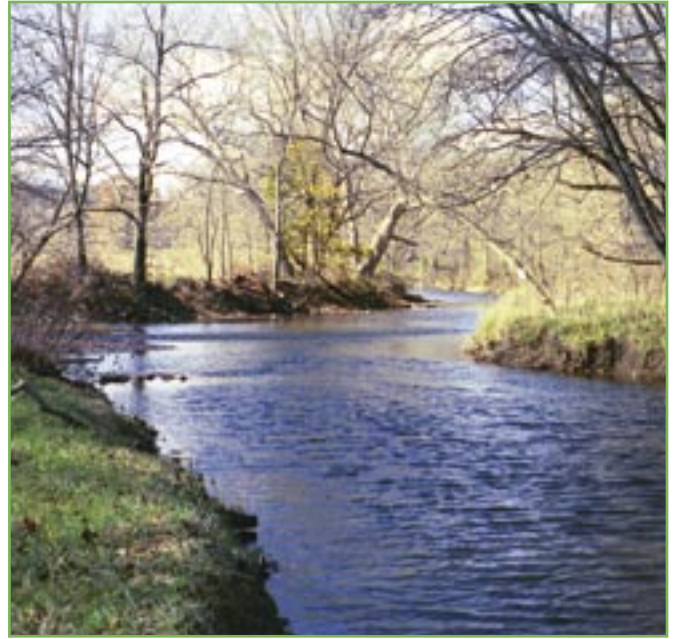
Mill Creek's mouth at Loyalhanna Creek in Ligonier.

borough officials have dredged and widened the area in the name of flood control. Due to development of the watershed upstream, Mill Creek is required to transport more water, flowing at a faster rate, than the stream is able to, causing excess flooding and water backups. One should also note that the lower end of Ligonier rests in a floodplain. Dredging has given the stream additional width. This creates more problems for the area, because when a stream is widened it drops its sediment in the middle of the stream instead of along its banks. This allows islands to form, which in turn grow vegetation. These islands have reformed since the dredging. The best plan for this section would be to attempt to narrow this stretch and speed up the flow. This would scrub the bottom of the stream and clean up some of the silt and mud from the streambed during normal flow. FTTU would suggest new alternatives for this area, along with education of elected officials.

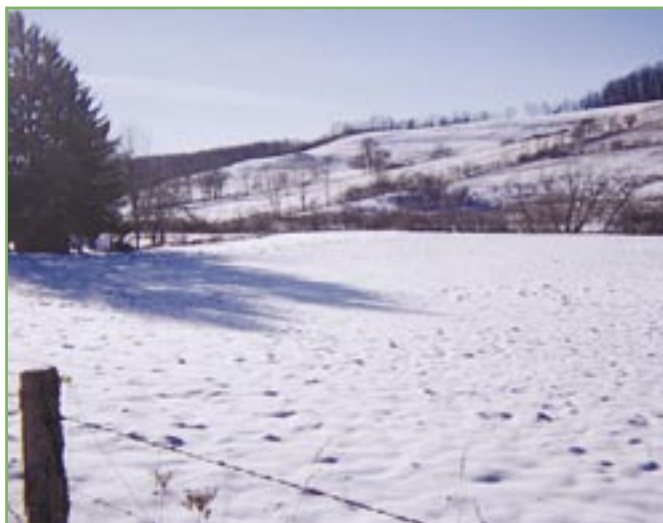
The Macks Run riparian zone is a mix of woodlots and fields

Macks Run flows south into the mainstem of Mill Creek in Waterford. It originates just across the Fairfield and Ligonier Township border, east of Route 711. It can be accessed via Hanna Walt Way and Harvey Road. It is classified as a cold water fishery, but does not receive annual trout stockings. It flows through private property along its entire length. In its upper stretch along Harvey Road, it flows through farmland and is impaired by agricultural runoff with little streamside cover. After passing through this area, Macks Run snakes its way through bottomland comprised of heavy cover. Crab apple, small trees, shrubs and multiflora rose make this area difficult to access. The stream in this section is well protected. It then flows into a small wooded area with a larger canopy. During the visual assessment, this section of stream was rated the highest. This area has good fish and macroinvertebrate habitat, deep pools, riffles and shade. Protecting this section of stream will play a key role in improving the quality of Mack's Run.

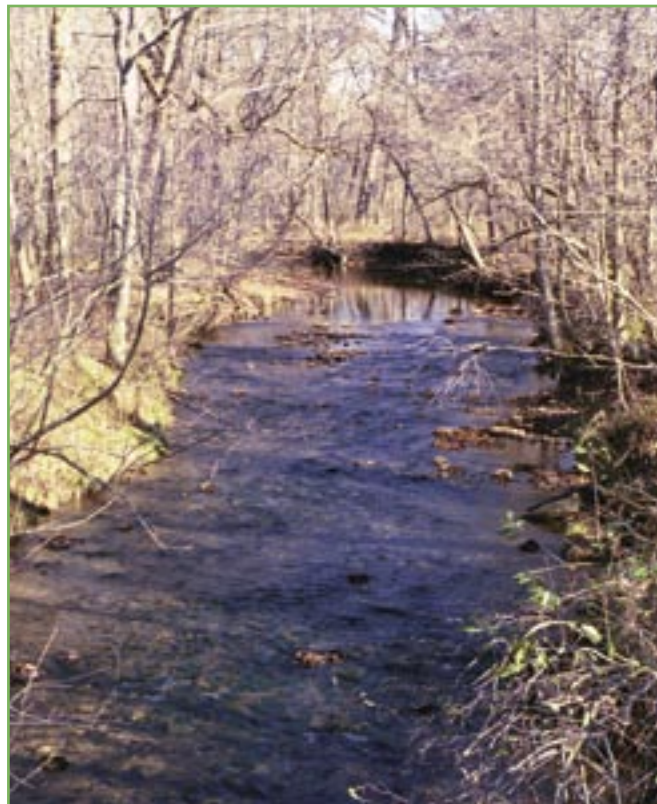
Hanna's Run

Hannas Run, aquatic life was visible, although it was difficult to find a great deal of habitat there to support it.

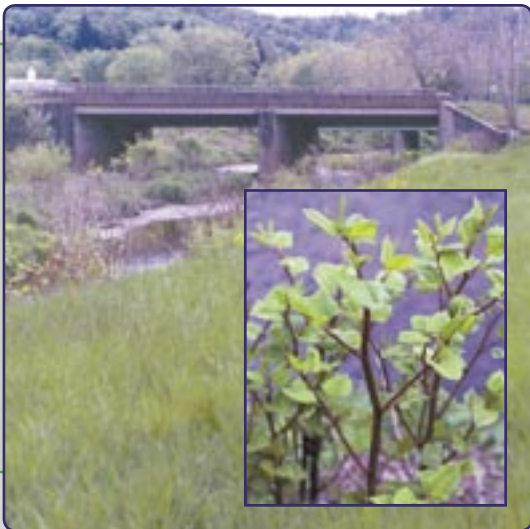
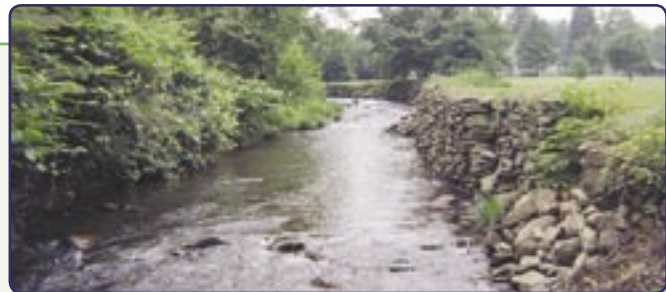
Areas where riparian vegetation has been removed are susceptible to erosion, allow invasive species such as Japanese Knotweed to move in and expose the stream to the warming effects of direct sunlight.

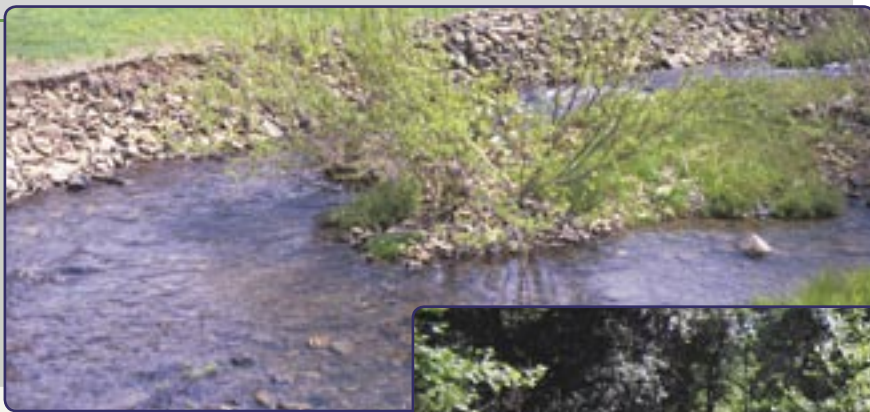
A braided channel and > excessive siltation. The absence of riparian vegetation has allowed the bank to erode.

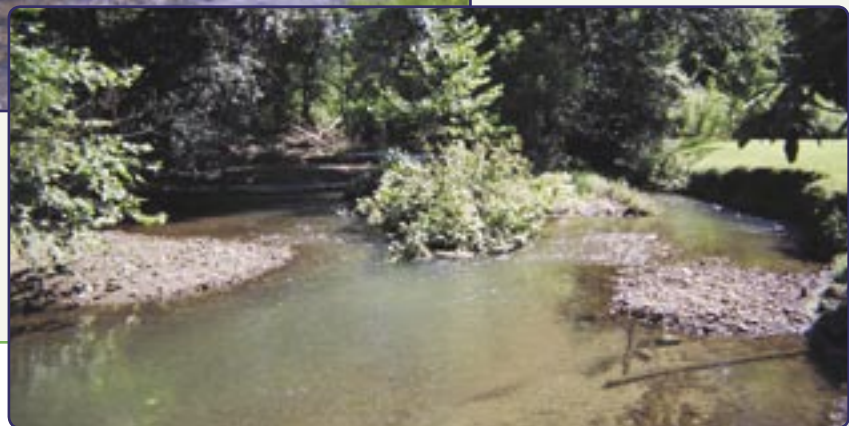
< A lack of riparian cover has exposed the stream to the warming effects of sunlight. The stream has dropped sediment here forming an island.

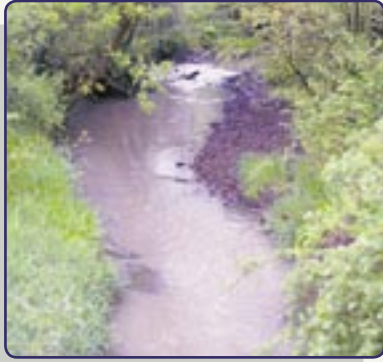
Mill Creek's tributaries muddy quickly in a rainstorm and bring in silt, smothering the cobblestones and woody debris in the stream bed that serves as habitat for macroinvertebrates.

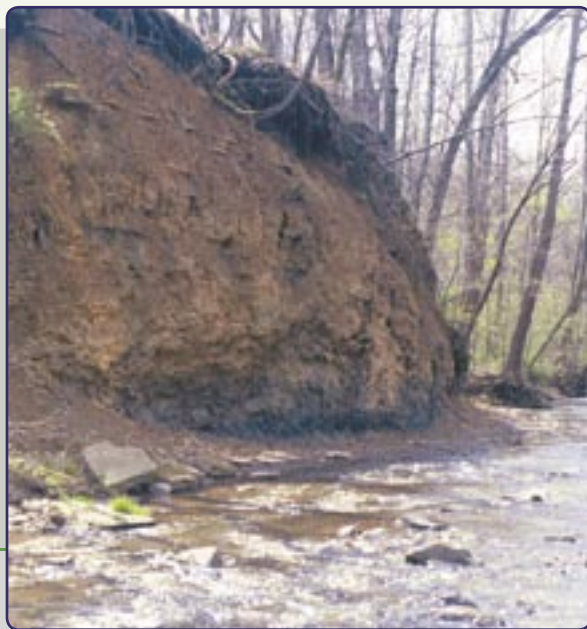
Bank erosion in the Mallard Lane area.

The most impacted area in this section is the highly eroded bank at the end of Mallard Road. Some large rocks have been placed above this section to protect the road. The erosion, which begins just after this area, would be a high priority for FTTU to repair. This could be accomplished by further extending the stabilization efforts to protect the roadway and by constructing fish habitat devices. Partnering with landowners and other agencies, such as Ligonier Township and the PAFBC, would benefit this area.

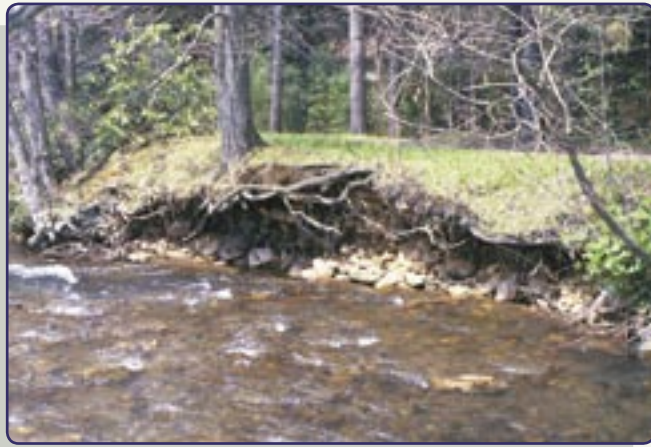
^ Bank erosion threatens a private road.

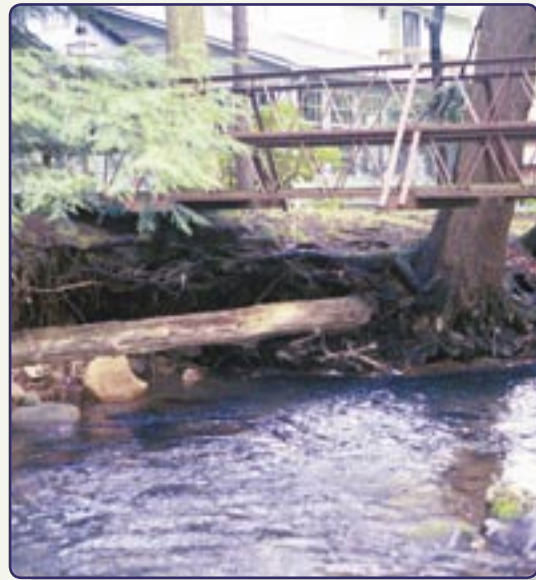
A severely eroded bank and a hemlock tree > in danger of falling in the Mill Road area.

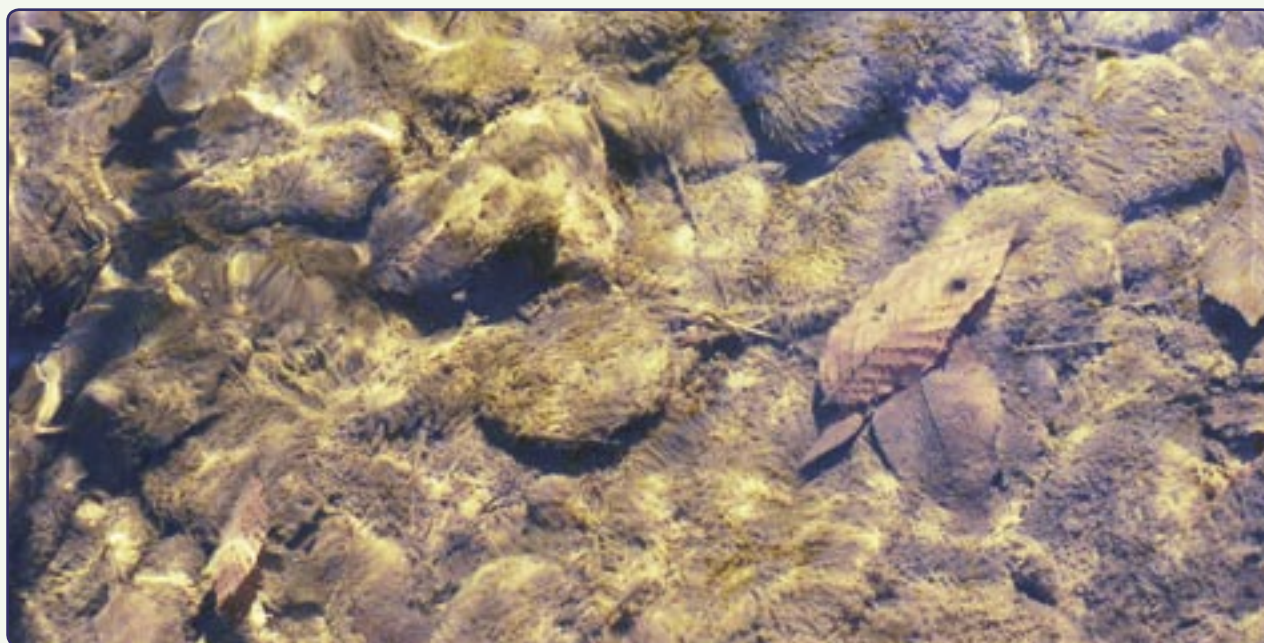
Excessive algae growth from nutrient enrichment.
