Brubaker Run Assessment and Coldwater Conservation Plan

February 2018

Prepared by
Trout Unlimited
18 East Main Street, Suite 3
Lock Haven, PA 17745

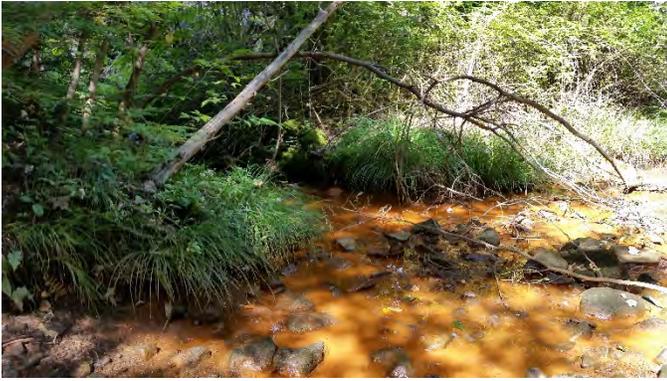
Abandoned Mine Drainage at Site BRT 60

Strategy 2: AMD/AML Restoration and Monitoring – Efforts should be made to address the remaining AMD and AML issues throughout the watershed through reclamation, re-mining, water treatment, and reforestation. Water quality and biological monitoring should continue to gauge the success of restoration projects and provide data aimed at removing streams from the DEP impaired waters list and upgrading stream status where possible. Along those lines, research should be conducted to determine if sulfate and/or other pollutants are thwarting biological recovery in the watershed, and if so, what is the appropriate way to measure stream recovery on a biological level post mining and reclamation. Additionally, there are un-reclaimed priority AML areas throughout the watershed (Figure 4, above) that should be remediated not only because they pose human health and safety hazards, but also because they would help reduce AMD and sediment pollution. In addition, there are efforts underway in the mining reclamation community to convert sites that were previously restored as grasslands/meadows to productive forestlands. There are several sites in the watershed that could benefit from this approach.

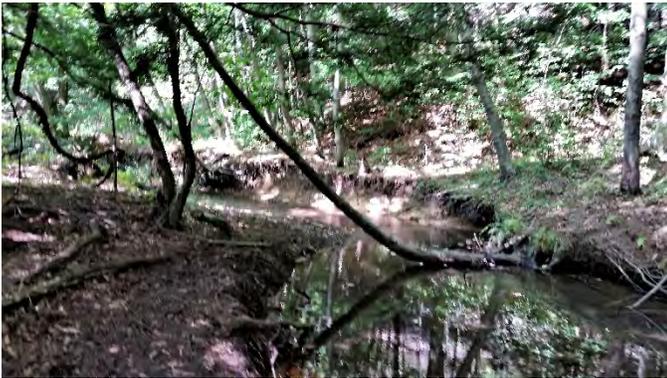
Bank erosion along Little Brubaker Run

Strategy 3: Habitat and Bank Stabilization Projects – Efforts should continue to identify areas in need of bank stabilization and/or instream habitat projects that would reduce sediment pollution and provide habitat for fish and other aquatic species. There are many areas in Hastings Borough that are eroding and in need of stabilization. Brubaker Run near Site BR2 has some areas of bank erosion that should be addressed as well. Regarding streamside habitat, there are several areas of the watershed that could benefit from riparian buffer plantings and reforestation, mainly in Hastings (residential) and Driscoll Hollow (AML reclamation). The project partners should work with municipalities and private landowners along Brubaker Run to encourage implementation of riparian buffers.

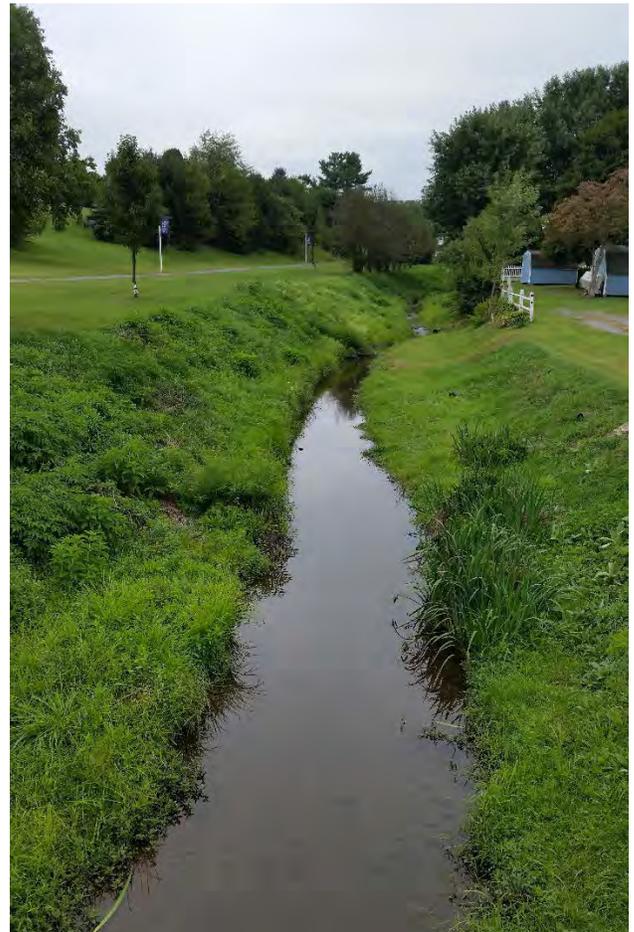
Channelization, sedimentation, and lack of buffers in Hastings Borough
