# Laurel Hill Creek River Conservation Plan DCNR Plan RCP-7-18

Laurel Hill Creek River Conservation Plan Somerset County, Pennsylvania DCNR Plan RCP-7-18

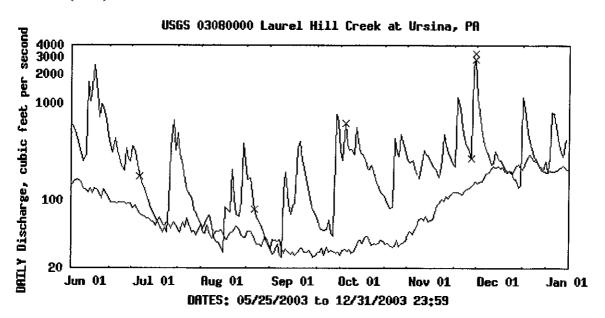
Graph WR-2. Stream flow for Laurel Hill Creek at Ursina from June through December 2003. The stream monitoring during the June to September 2003 period represents above average flow conditions. Source of data is USGS (2004).

- EXPLANATION
- --- MEDIAN DAILY STREAMFLON BASED ON 84 YEARS OF RECORD
- × MEASURED Discharge
- --- DAILY MEAN DISCHARGE

More recent flow data for Laurel Hill Creek are provided in Graph WR-2 for the June to December 2003 period. Flows during this recent time period are clearly greater than the median flows for the Creek based on the 84 years of recorded data. The flows measured as part of this River Conservation Plan, shown in Table WR-2, therefore represent flows that are above average.

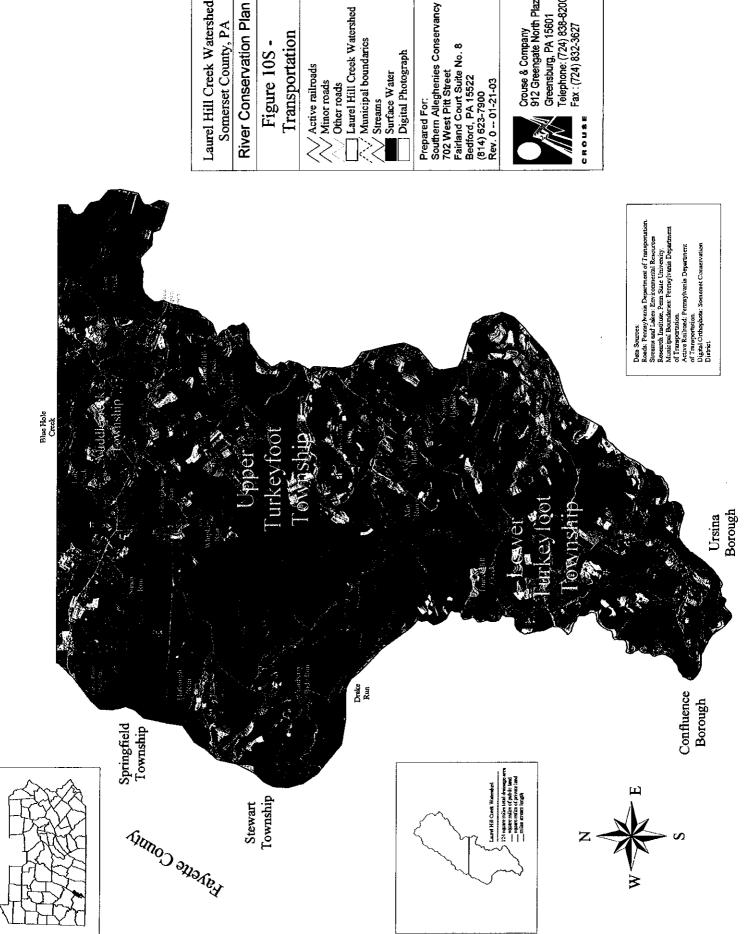
#### Transportation Figure 10S -

Transportation routes are identified in Figure 10 and were based on Pennsylvania Department of Transportation maps.
