Mill Creek Watershed WESTMORELAND COUNTY PENNSYLVANIA

Conservation Plan

Prepared By The Forbes Trail Chapter Of Trout Unlimited Funded By A Grant From The Coldwater Heritage Partnership

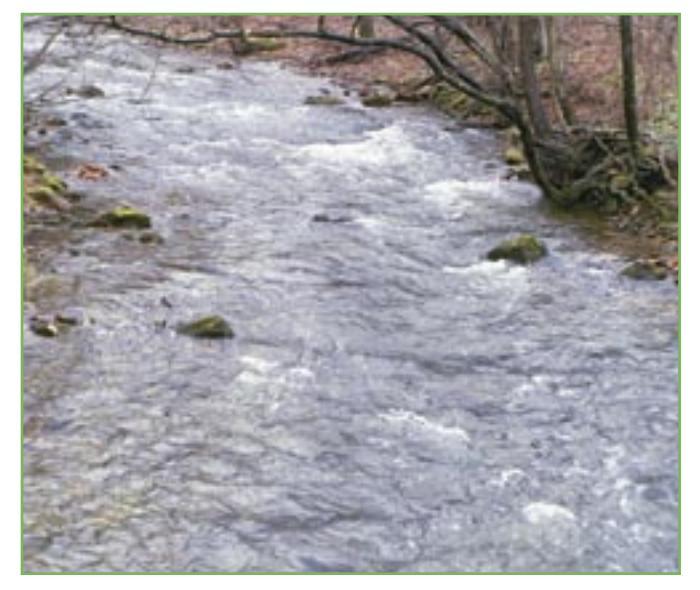
Mill Creek flows relatively clear during high water just above the Ann Roberts bridge

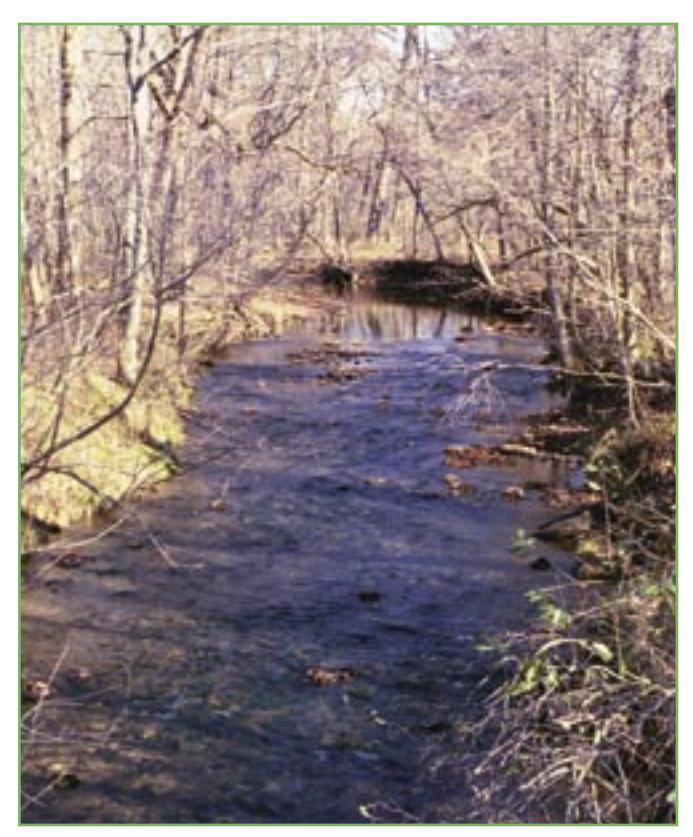
Hanna's Run

Hannas Run, aquatic life was visible, although it was difficult to find a great deal of habitat there to support it.

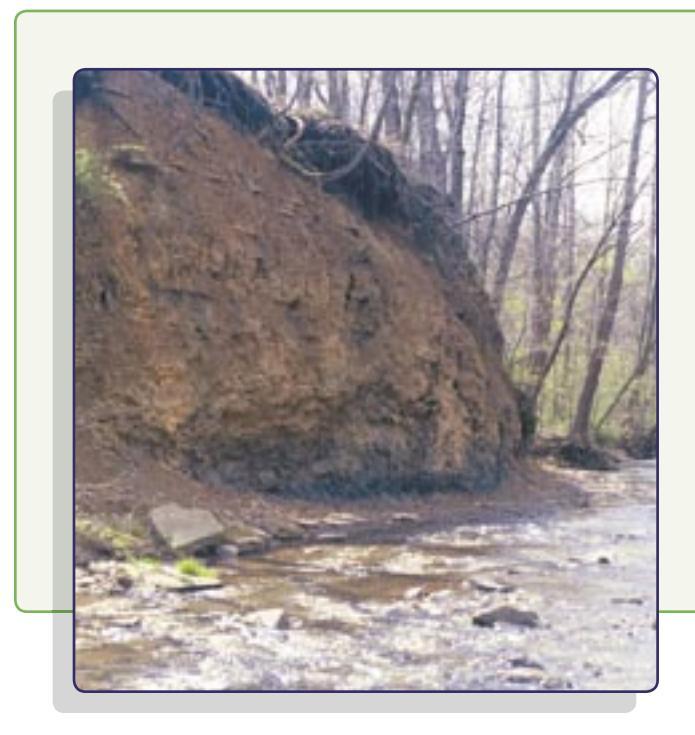
The most impacted area in this section is the highly eroded bank at the end of Mallard Road. Some large rocks have been placed above this section to protect the road. The erosion, which begins just after this area, would be a high priority for FTTU to repair. This could be accomplished by further extending the stabilization efforts to protect the roadway and by constructing fish habitat devices. Partnering with landowners and other agencies, such as Ligonier Township and the PAFBC, would benefit this area.

Bank erosion in the Mallard Lane area.
